## P238 Product Alert

### P238 Product Alert – Reassembly

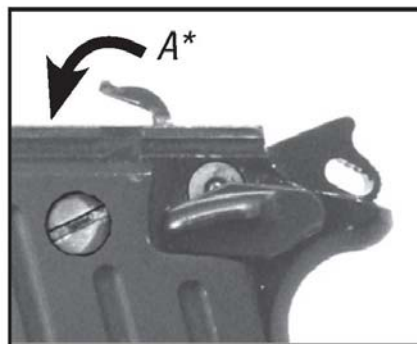
**“4. Guide the slide assembly onto the frame rails from the front until the barrel lug is aligned with slide stop pin hole in frame and partially insert slide stop pin.**

**- note: depress the ejector “A” to clear slide.\*”**

The ejector should be depressed only far enough to provide clearance for the slide during assembly. Depressing the ejector beyond the point required for reassembly may cause the ejector to bind in the frame. Should this occur, the ejector will not return to the normal position. This condition is not correctable at the operator level - the pistol will have to be returned to SIG SAUER for repair.

**CAUTION: OVER EXTENTION OF THE EJECTOR DURING ASSEMBLY MAY CAUSE THE EJECTOR TO BIND, PREVENTING SHELL CASINGS TO EJECT DURING FIRING.**

Should you have questions relating to this Product Alert or need to return your pistol for repair, please contact Customer Service at (603) 772-2302.
